## EAGLE RESIDENTIAL INSPECTION

365 N Indian House Rd  
Tucson, AZ 85711

04/25/2023

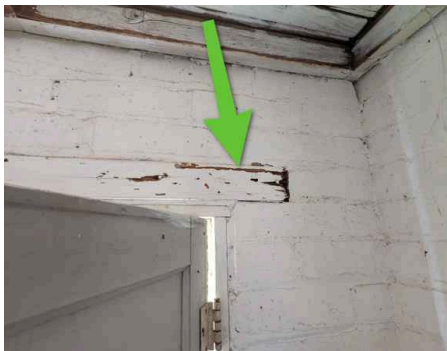
Termite damage to door sill in guest house laundry room

While identifying pest intrusion is not a required part of a home inspection, if I identify signs of intrusion I note it and recommend a separate Pest Inspection be performed on the property.

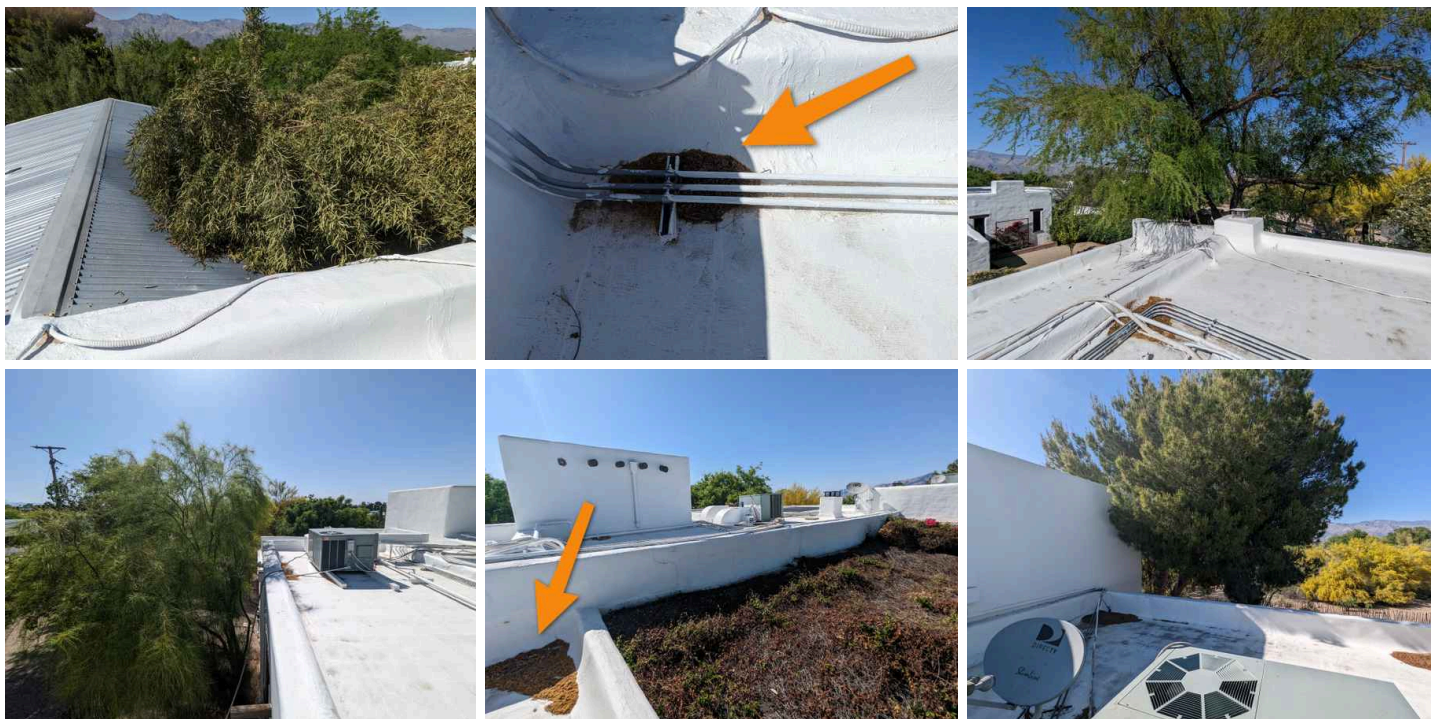
Debris detracts from the roof's ability to shed water and can cause ponding and premature wear. Due to the amount of tree overhang and vegetation attached to the house there is a lot of debris on both the main house and guest house. Recommend periodic cleaning to prevent debris build up.

Contact a handyman or DIY project

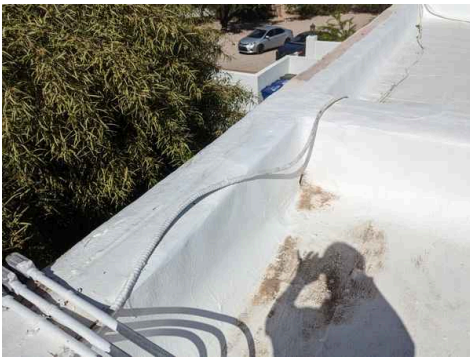
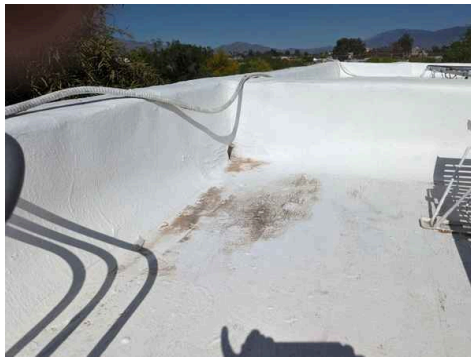
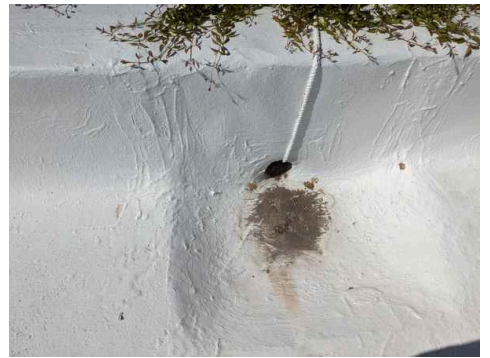
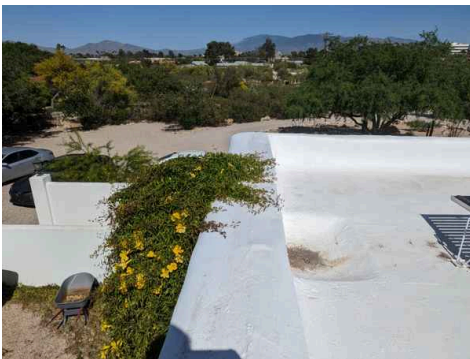
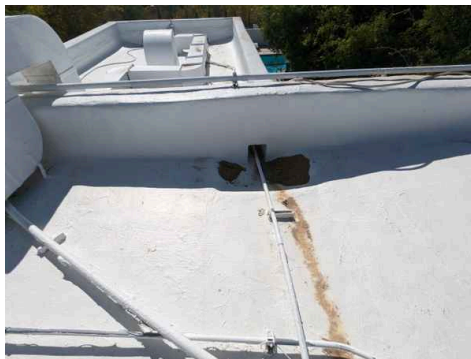
2.1.2 Coverings

**PONDING**

Observed ponding in many areas of all roof surfaces. Ponding is an area of a roof covering that is either not sloped enough or has debris that does not allow the roof to shed water within 24 hours after a rain. This can lead to accelerated erosion and deterioration. Recommend a qualified roofing contractor evaluate and repair.

Contact a qualified roofing professional.

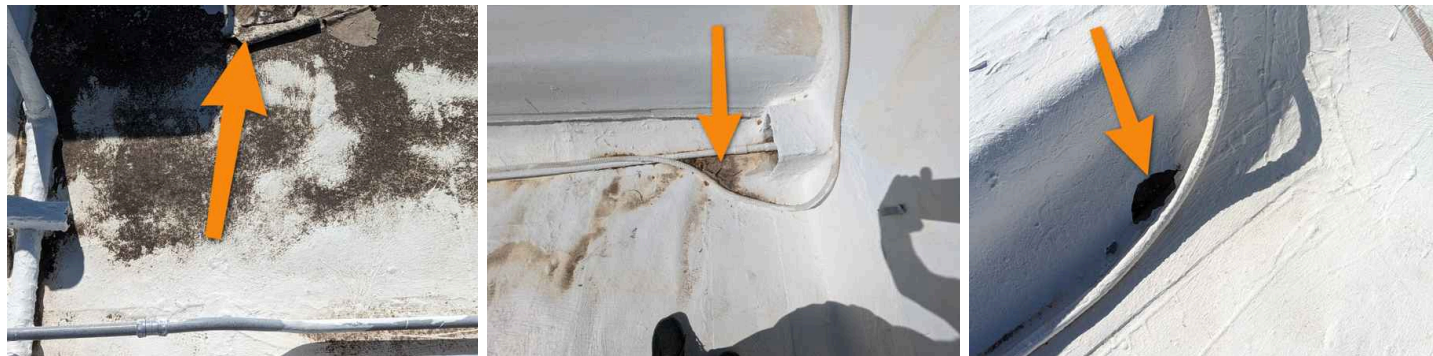
### 2.1.3 Coverings

#### **DAMAGED (GENERAL)**

Roof coverings showed moderate damage where the roof covering and sealant has worn and is in need of immediate repair. Recommend a qualified roofing professional evaluate and repair.

\* These are examples only. There are additional areas that should be inspected for damage and worn sealant.

Contact a qualified roofing professional.

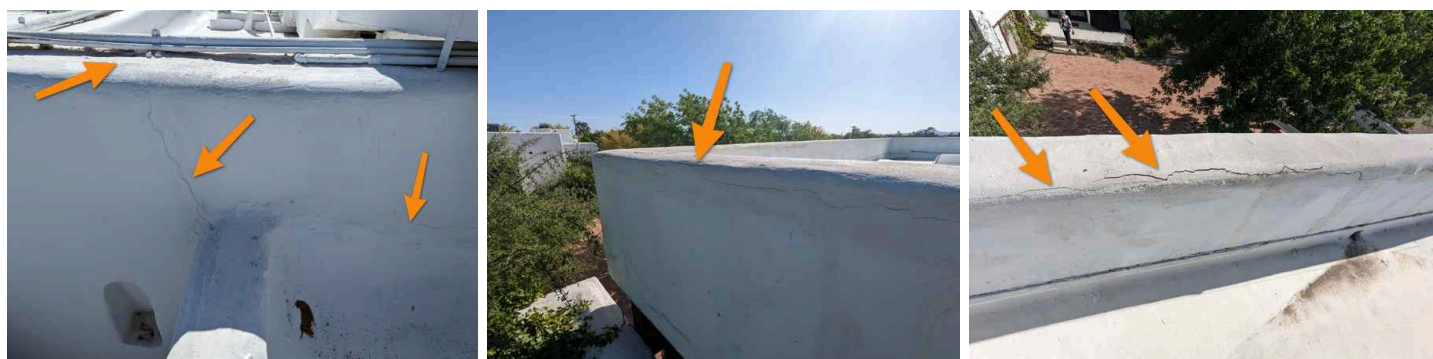
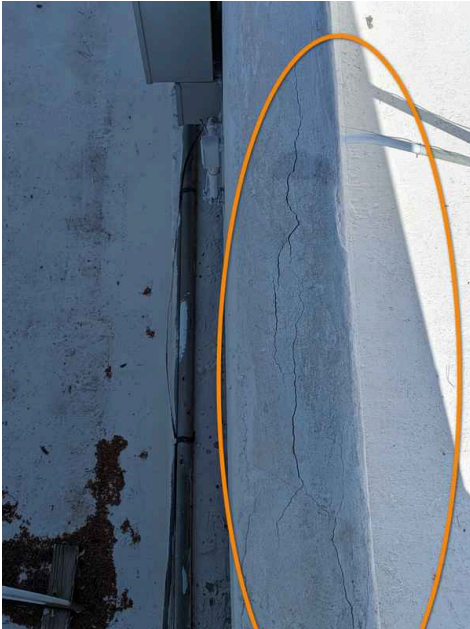
### 2.1.4 Coverings

#### **DAMAGE TO PARAPET**

\* Some photos show damage to the parapet as well as walls.

Recommend roofing contractor evaluate repairs needed to repair and seal the parapets against moisture intrusion

Contact a qualified professional.

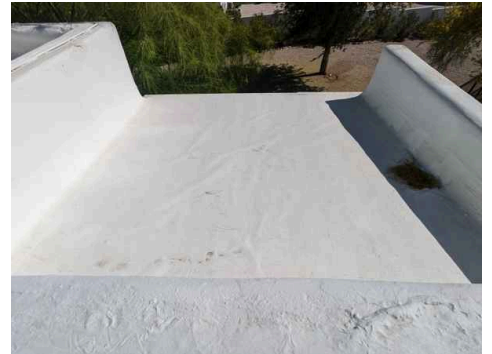
### 2.1.5 Coverings

#### **WAVES ON ROLL ROOFING**

Waves were observed on the roll roofing. This can be caused by a number of issues and is often easily repaired, but must be repaired to prevent the spread to adjacent areas.

Waves in roofing that extend to seams or edges can allow moisture and air under the roof covering material that will result in deterioration of the roofing material and potential damage to the decking..

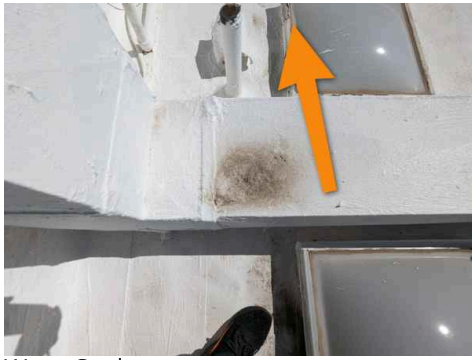
Proper flashing and sealing around skylights is critical and one skylight has worn sealant. Recommend resealing skylights where worn..

Worn Sealant

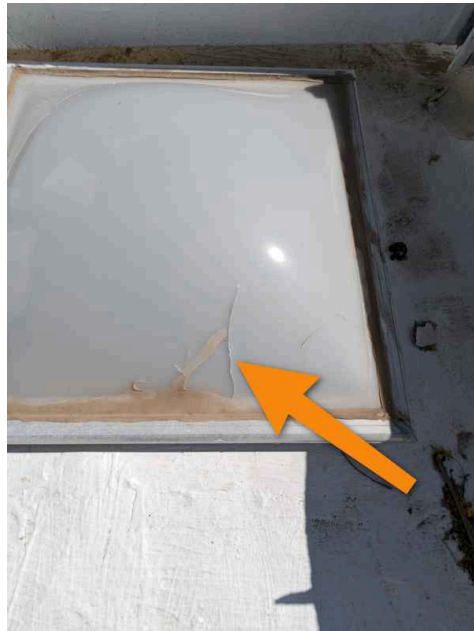
One skylight is cracked and requires sealing or replacement. There is a new skylight in the guest house laundry room that may have been purchased to replace the cracked one.

Cracked Skylight

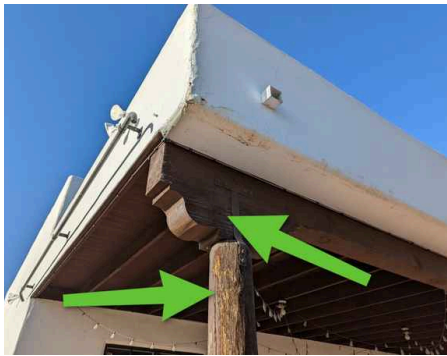
There are a number of areas with exposed wood that should be sealed.

I highly recommend that all exterior exposed wood be either sealed or painted in order to prevent moisture or pest intrusion. A sealant will protect the surface and prevent deterioration.

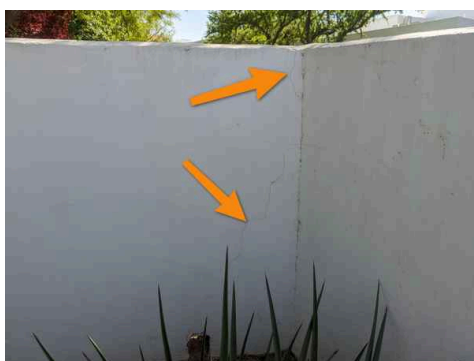
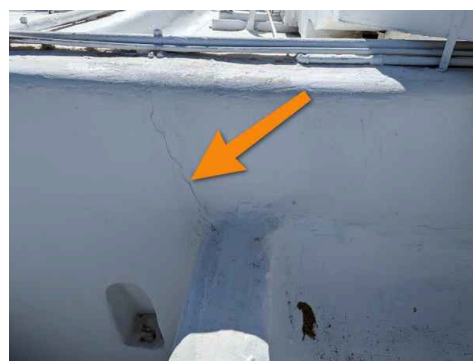
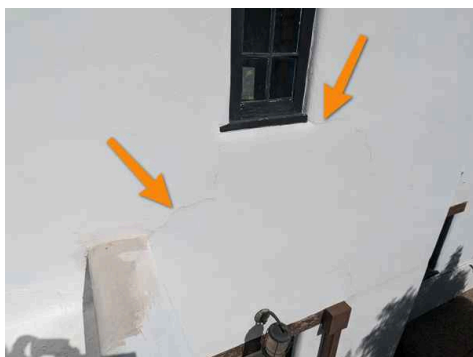
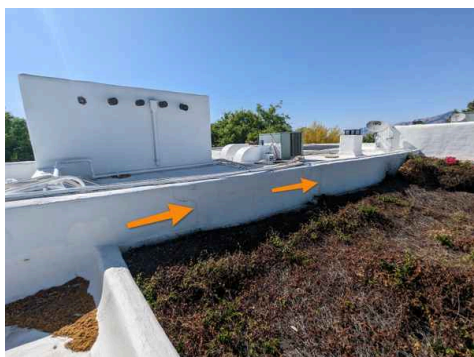
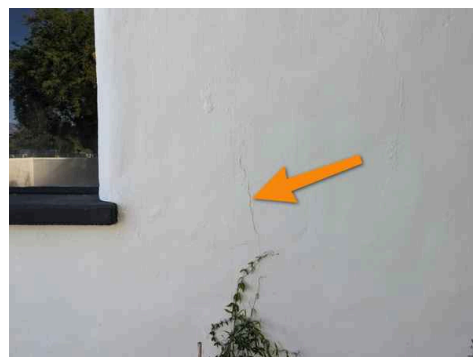
#### CRACKING - MINOR

Siding showed cracking in many places as expected with a house of this age and construction as a result of temperature changes and settling. Recommend having the walls evaluated for repair. Some larger cracks and previous repairs may be the result of foundation shifting and should be monitored for future shifting.

Border Wall

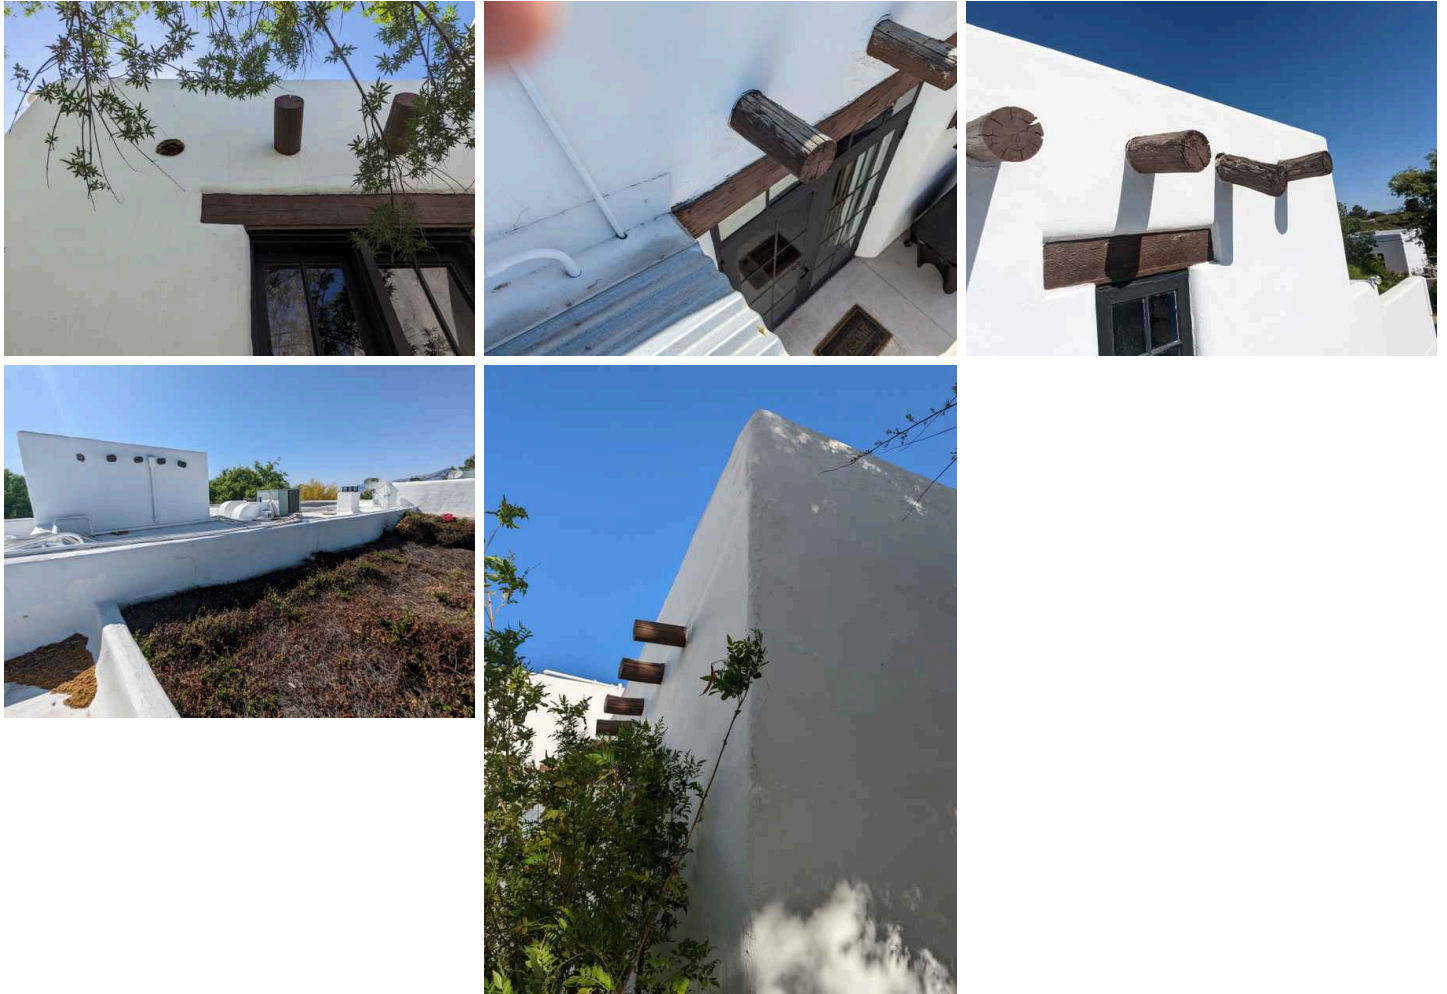
## 3.1.2 Siding, Flashing &amp; Trim

**DAMAGED VIGAS (DECORATIVE WOOD PROTRUDING FROM WALLS)**

Many vigas are damaged or missing. Recommend replacing and keeping all exterior wood painted or sealed to protect against water damage and pest intrusion

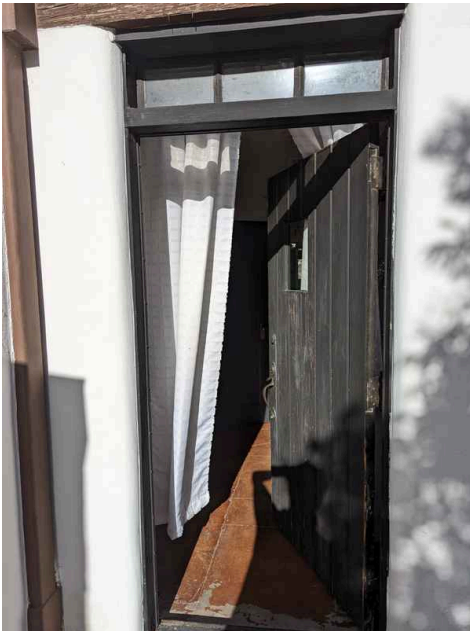
**DOOR STICKS**

The exterior door to the 2nd bedroom's bathroom sticks - recommend adjusting to allow for proper function

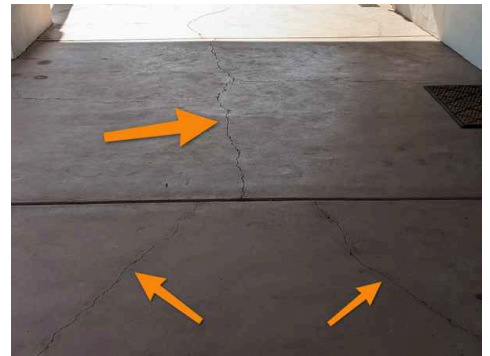
### 3.5.1 Patios & Porches

#### **PATIO FLOOR CRACKING - MINOR**

Guest house patio has normal settling & cracking observed. Recommend monitor and/or patch/seal.

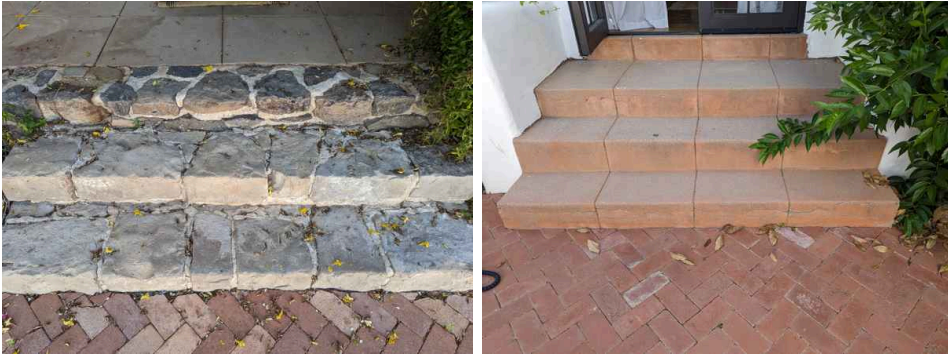
#### **MINOR DETERIORATION**

Some minor deterioration and worn mortar exists that should be repaired to prevent further deterioration. Concrete steps have minor cracks that I recommend sealing to prevent deterioration.

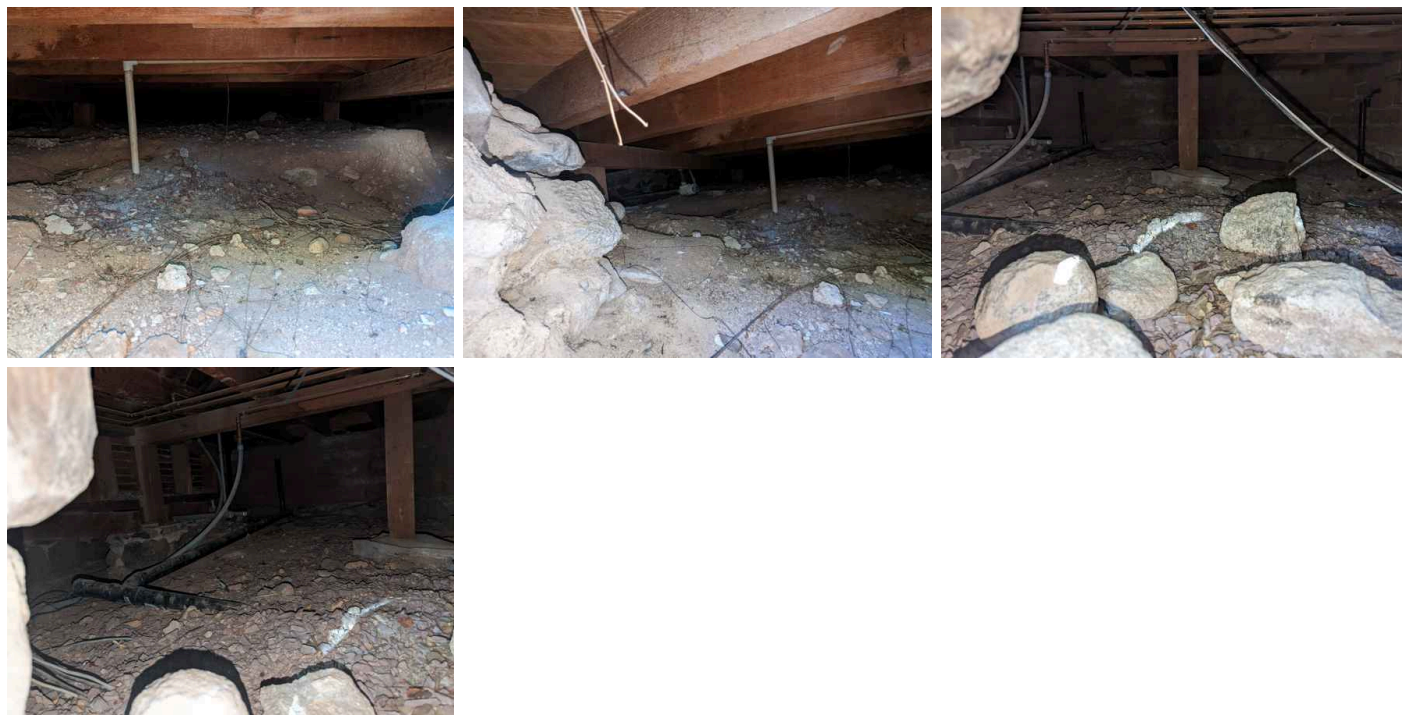
### Foundation: Residence Foundation Material(s)

Stone, Pier and Beam

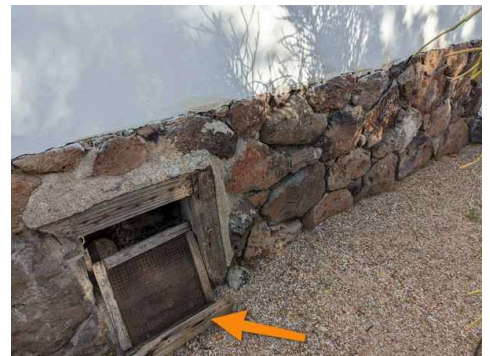
#### **ACCESS HATCH DAMAGE**

The access hatch to the crawlspace on the west side of the house is damaged. Recommend repair to prevent pest intrusion

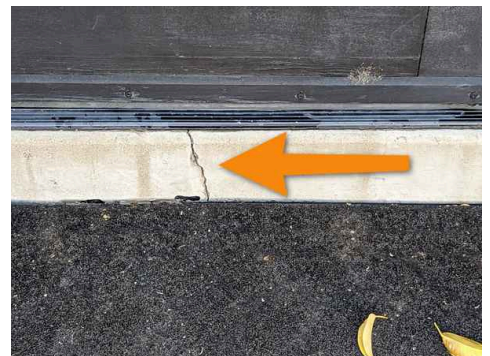
### 4.2.1 Foundation

#### **FOUNDATION CRACKS - MINOR**

Minor cracking was noted at the slab outside the door of the kitchen. This appears to be a very old crack but I recommend sealing and monitoring.

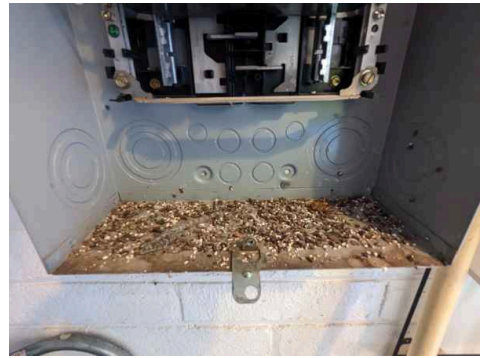
Electrical panels have a large amount of debris and dead lizards/spiders. I recommend having them cleaned by a qualified electrician while other electrical repairs are being performed.

Contact a qualified electrical contractor.

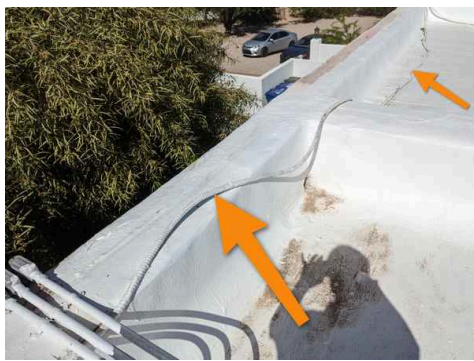
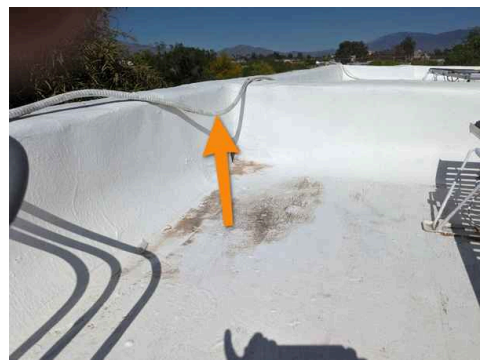
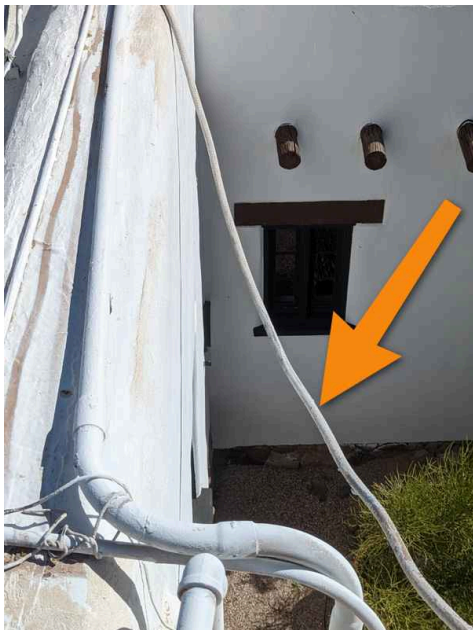
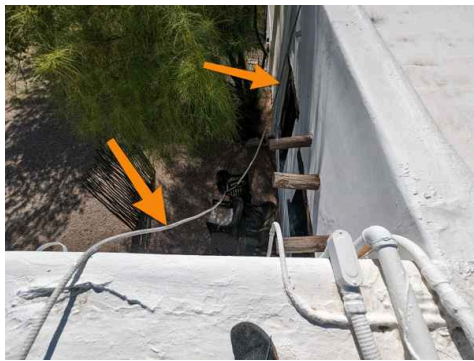
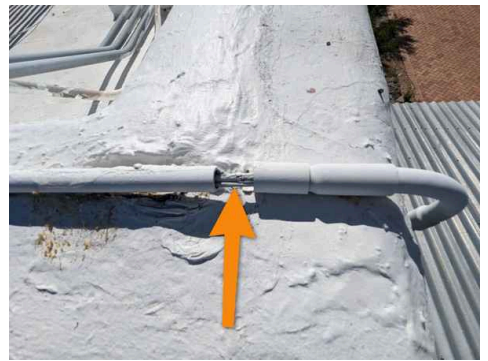
5.4.1 Branch Wiring Circuits, Breakers & Fuses

**LOOSE OR DISCONNECTED CONDUIT OR WIRING**

There are a number of issues where the electrical conduit is poorly supported or damaged. Recommend qualified electrician review visible electrical conduit and connections and secure to walls and roof to prevent further damage.

Broken Connection

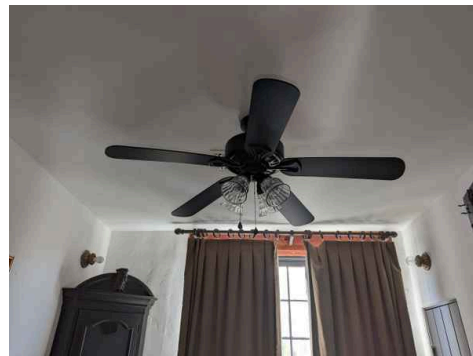
The ceiling light and fan in the library do not function. Recommend evaluation by electrical contractor.

Contact a qualified electrical contractor.

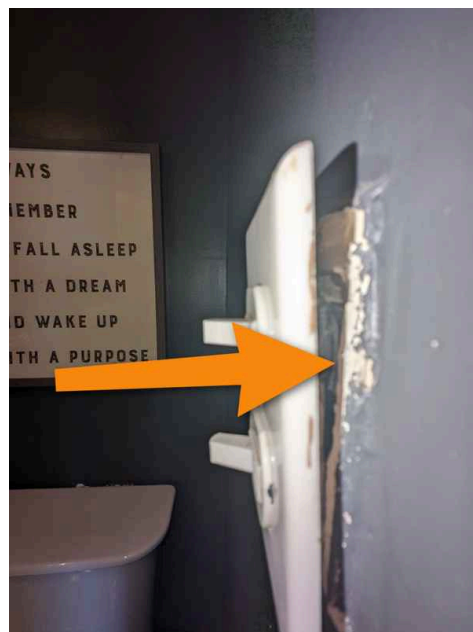
One outlet is not installed correctly in the guest house bathroom. Wall plates should be flush mounted. Recommend repairing to improve appearance.

Contact a qualified electrical contractor.

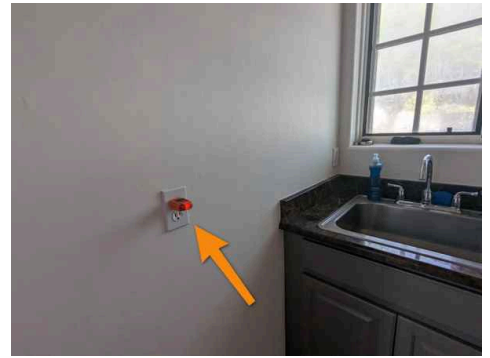
5.5.5 Lighting Fixtures, Switches & Receptacles

One receptacle is ungrounded in the guest house kitchen. To eliminate safety hazards I recommend this be rewired

Contact a qualified electrical contractor.

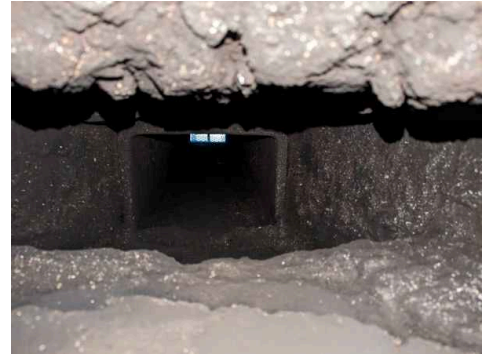
### 12.1.2 Vents, Flues & Chimneys

#### CHIMNEY LINER DIRTY

Contact a qualified chimney sweep.

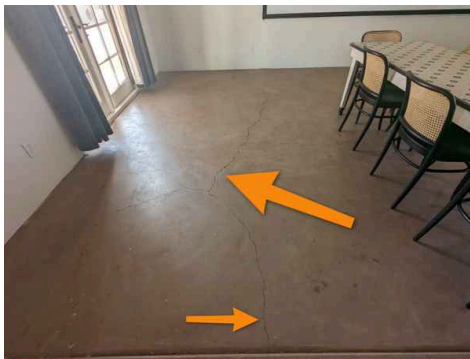
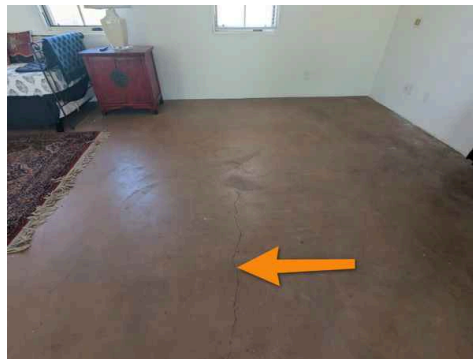
13.3.1 Floors

### CRACKED FLOORING

There are minor cracks in concrete floor of the guest house. Recommend monitoring

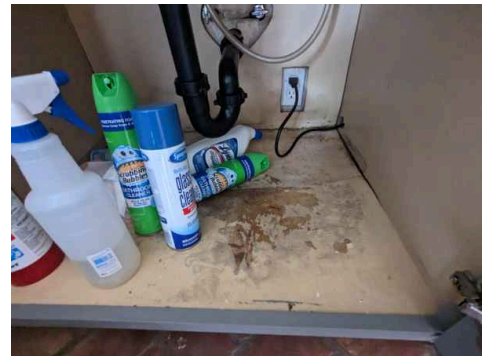
### 13.7.1 Countertops & Cabinets

#### **CABINETS DAMAGED**

Contact a qualified cabinet contractor.
