## EAGLE RESIDENTIAL INSPECTION

XXX Rd  
Tucson, AZ

04/25/2023

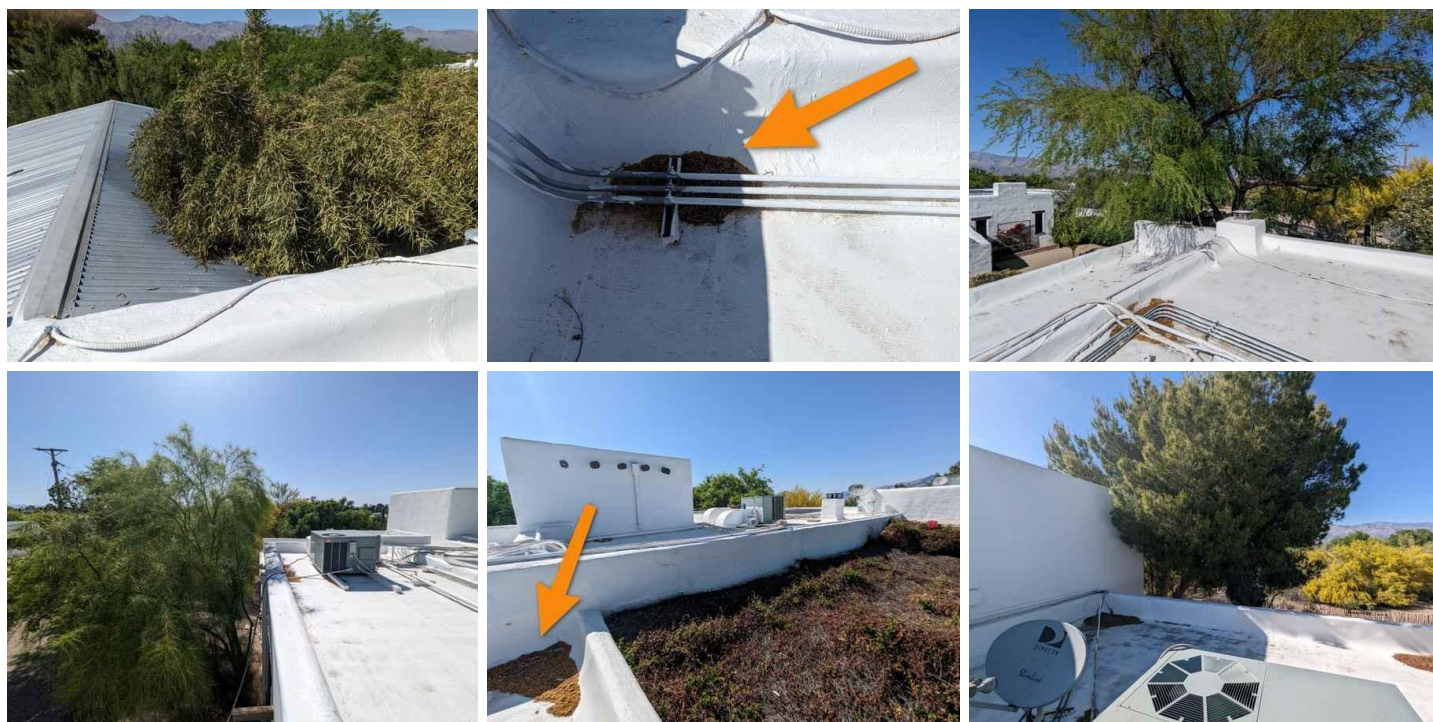
Debris detracts from the roof's ability to shed water and can cause ponding and premature wear. Due to the amount of tree overhang and vegetation attached to the house there is a lot of debris on both the main house and guest house. Recommend periodic cleaning to prevent debris build up.

Recommendation

Contact a handyman or DIY project

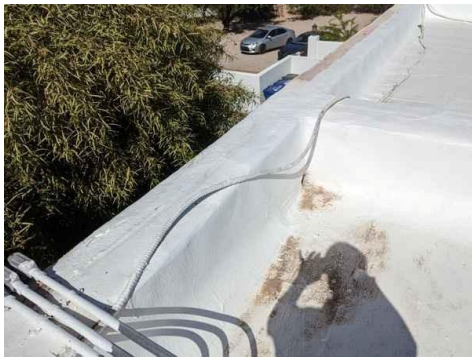
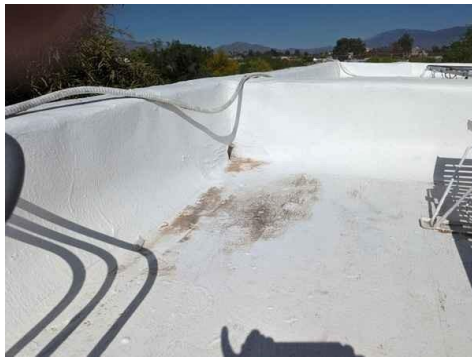
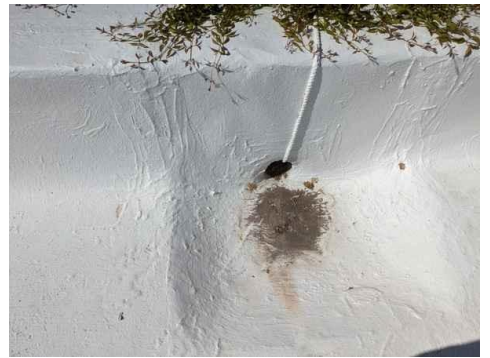
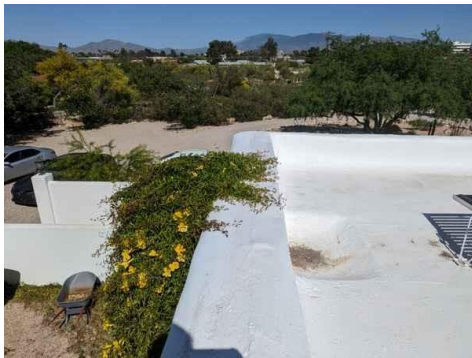
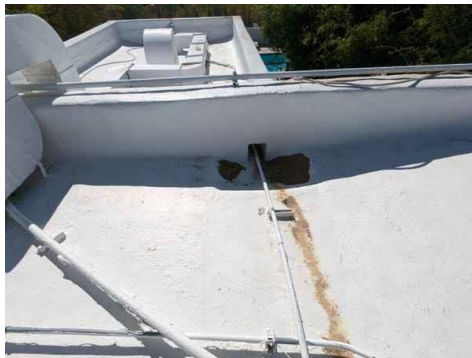
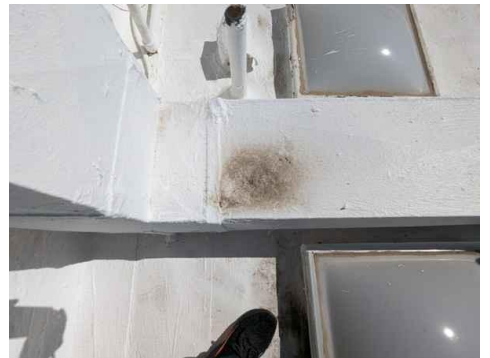
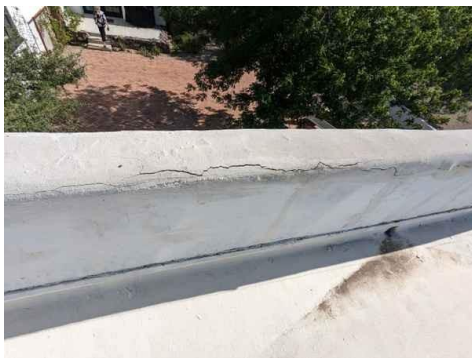
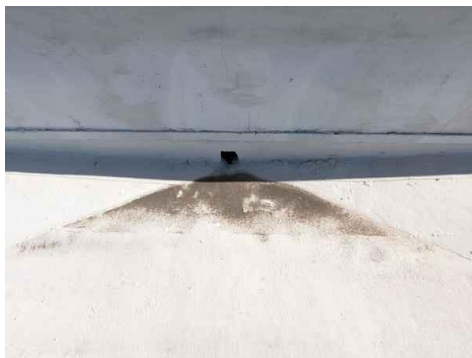
### 2.1.2 Coverings

Observed ponding in many areas of all roof surfaces. Ponding is an area of a roof covering that is either not sloped enough or has debris that does not allow the roof to shed water within 24 hours after a rain. This can lead to accelerated erosion and deterioration. Recommend a qualified roofing contractor evaluate and repair.

#### Recommendation

Contact a qualified roofing professional.

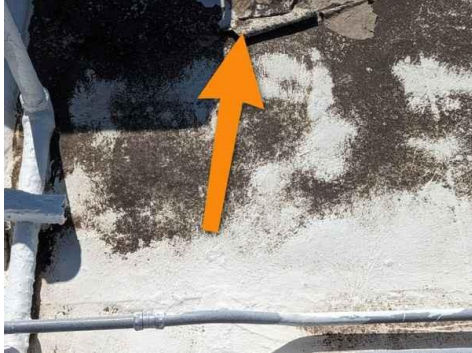
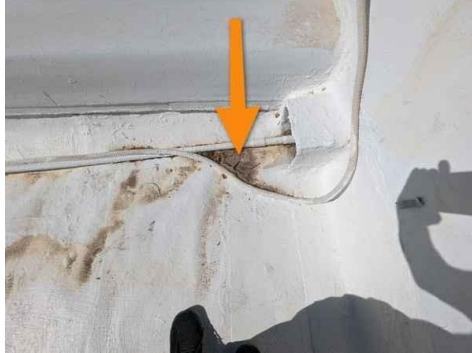
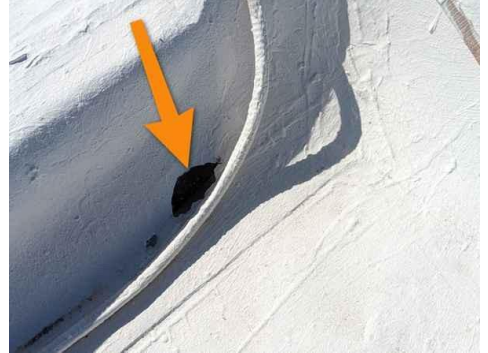
## 2.1.3 Coverings

**DAMAGED (GENERAL)**

Roof coverings showed moderate damage where the roof covering and sealant has worn and is in need of immediate repair. Recommend a qualified roofing professional evaluate and repair.

\* These are examples only. There are additional areas that should be inspected for damage and worn sealant.

Recommendation

Contact a qualified roofing professional.

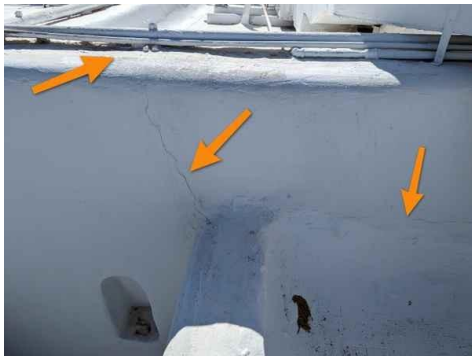
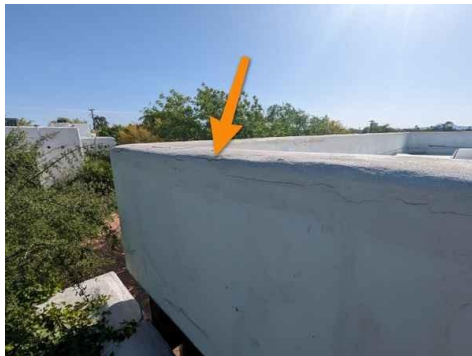
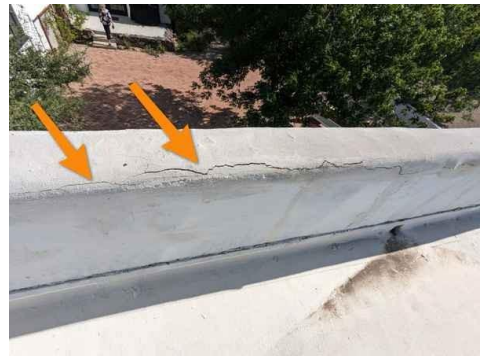
## 2.1.4 Coverings

**DAMAGE TO PARAPET**

\* Some photos show damage to the parapet as well as walls.

Recommend roofing contractor evaluate repairs needed to repair and seal the parapets against moisture intrusion

Recommendation

Contact a qualified professional.

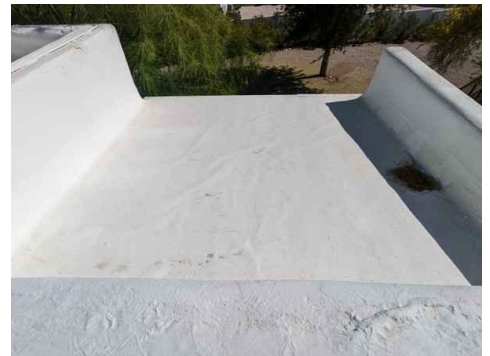
#### 2.1.5 Coverings

Waves were observed on the roll roofing. This can be caused by a number of issues and is often easily repaired, but must be repaired to prevent the spread to adjacent areas.

Waves in roofing that extend to seams or edges can allow moisture and air under the roof covering material that will result in deterioration of the roofing material and potential damage to the decking..

Recommendation

Contact a qualified professional.

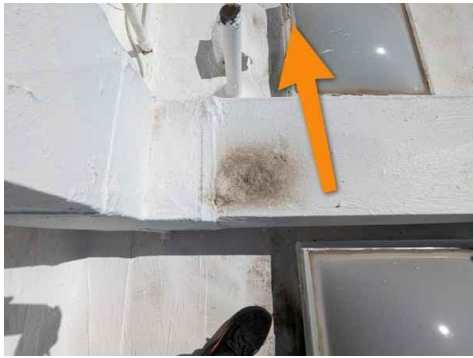
Proper flashing and sealing around skylights is critical and one skylight has worn sealant. Recommend resealing skylights where worn..

Worn Sealant

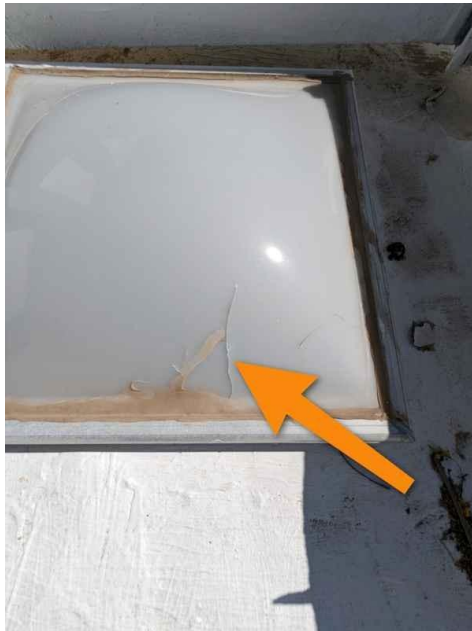
One skylight is cracked and requires sealing or replacement. There is a new skylight in the guest house laundry room that may have been purchased to replace the cracked one.

Cracked Skylight

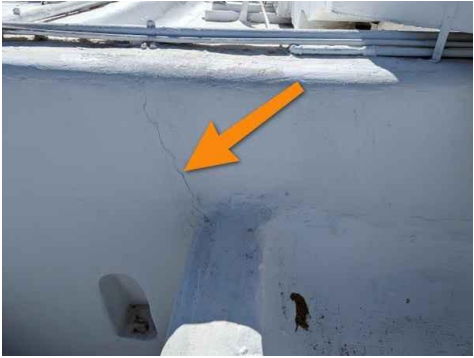
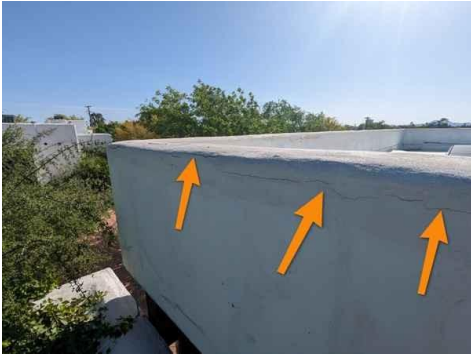
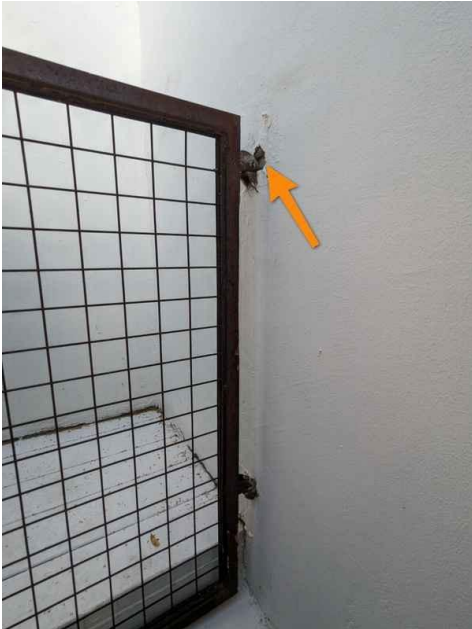
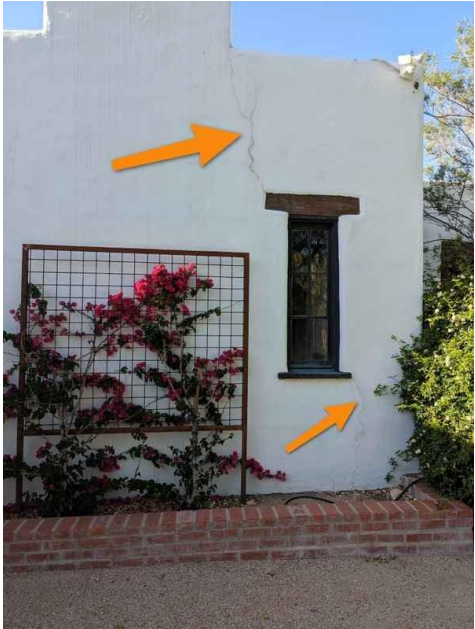
#### CRACKING - MINOR

Siding showed cracking in many places as expected with a house of this age and construction as a result of temperature changes and settling. Recommend having the walls evaluated for repair.

Some larger cracks and previous repairs may be the result of foundation shifting and should be monitored for future shifting.

Recommendation

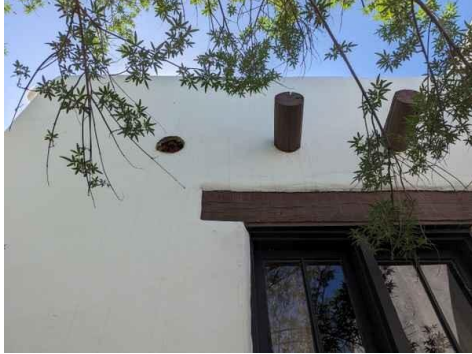
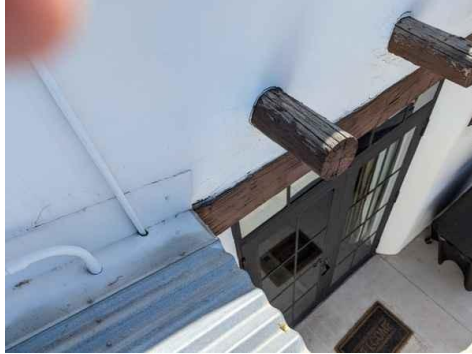
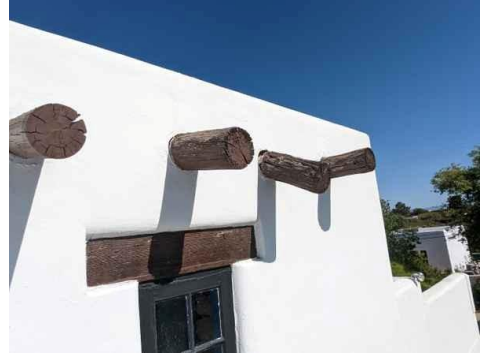
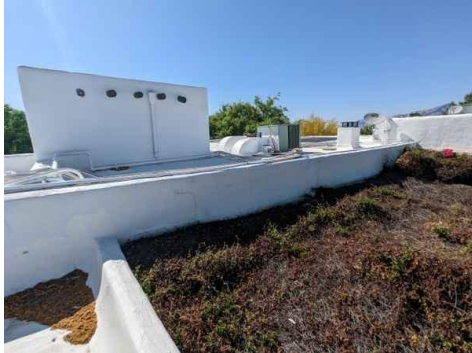
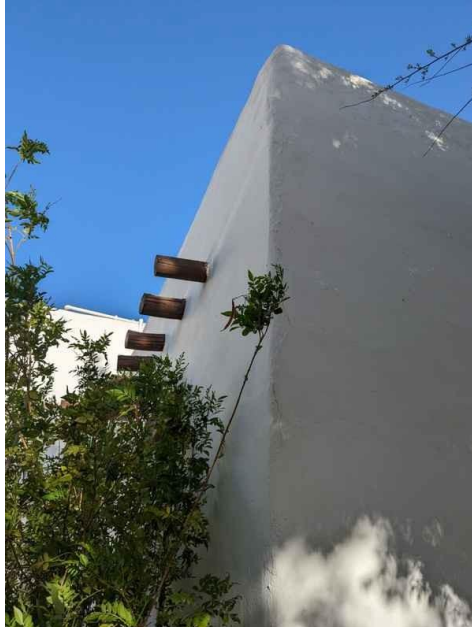
#### **DAMAGED VIGAS (DECORATIVE WOOD PROTRUDING FROM WALLS)**

Many vigas are damaged or missing. Recommend replacing and keeping all exterior wood painted or sealed to protect against water damage and pest intrusion

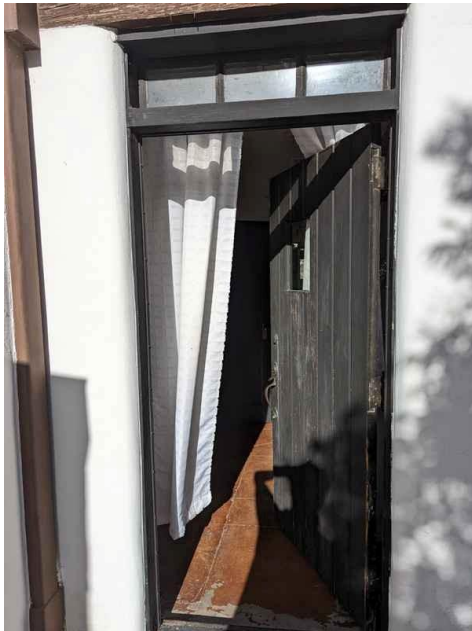
#### **DOOR STICKS**

The exterior door to the 2nd bedroom's bathroom sticks - recommend adjusting to allow for proper function

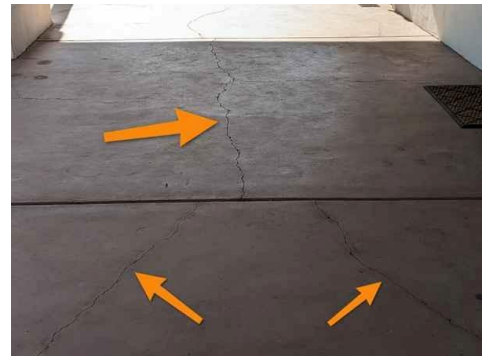
### 3.5.1 Patios & Porches

#### **PATIO FLOOR CRACKING - MINOR**

Guest house patio has normal settling & cracking observed. Recommend monitor and/or patch/seal.

Recommendation

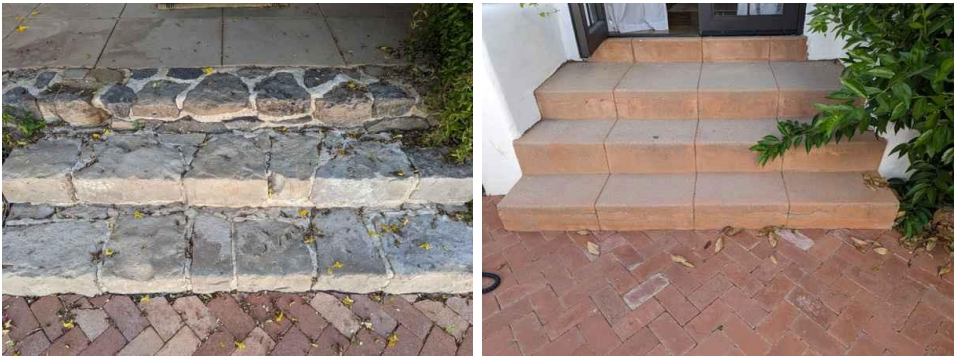
#### **MINOR DETERIORATION**

Some minor deterioration and worn mortar exists that should be repaired to prevent further deterioration. Concrete steps have minor cracks that I recommend sealing to prevent deterioration.

Recommendation

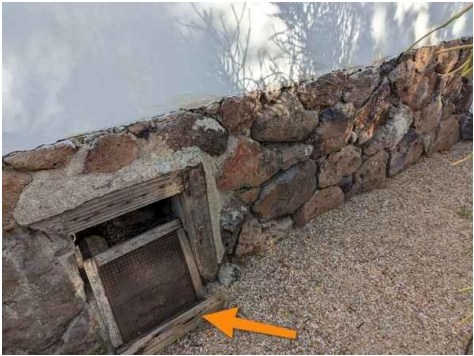
ACCESS HATCH DAMAGE

The access hatch to the crawlspace on the west side of the house is damaged. Recommend repair to prevent pest intrusion

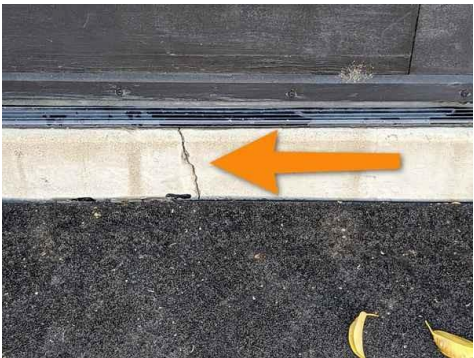
4.2.1 Foundation

FOUNDATION CRACKS - MINOR

Minor cracking was noted at the slab outside the door of the kitchen. This appears to be a very old crack but I recommend sealing and monitoring.

MONITOR

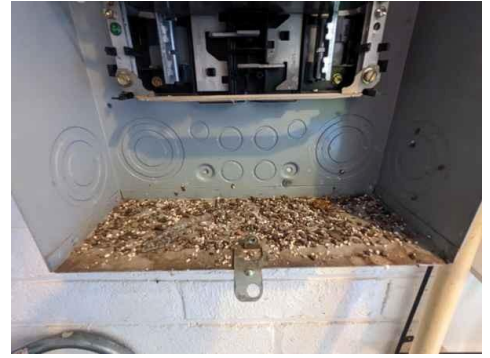
Electrical panels have a large amount of debris and dead lizards/spiders. I recommend having them cleaned by a qualified electrician while other electrical repairs are being performed.

Recommendation

Contact a qualified electrical contractor.

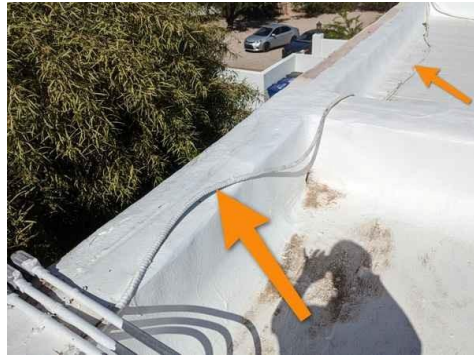
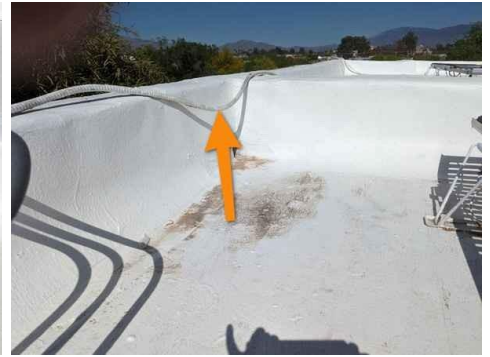
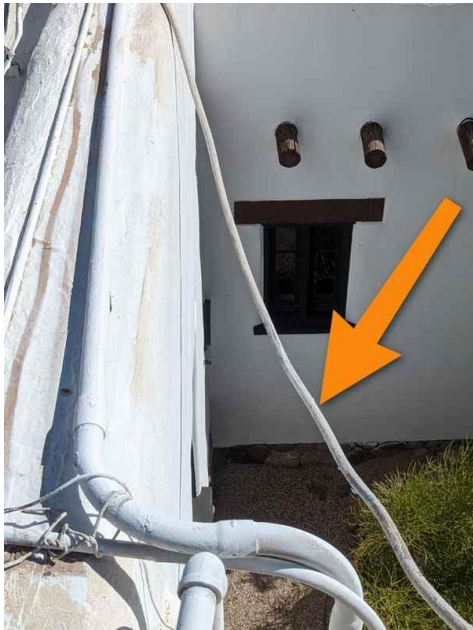
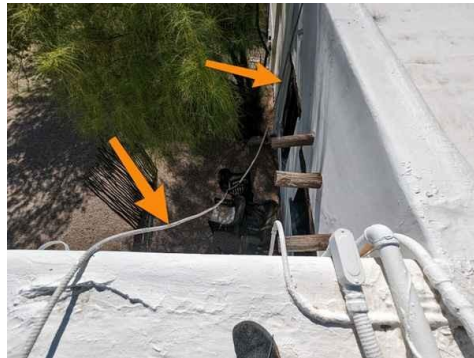
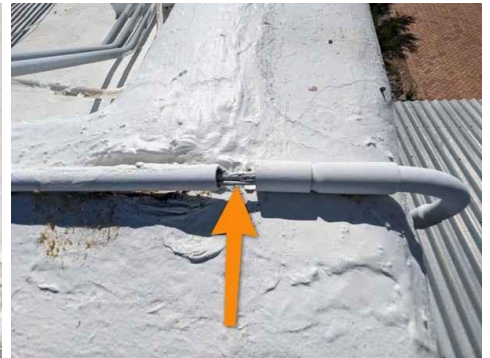
### 5.4.1 Branch Wiring Circuits, Breakers & Fuses

#### LOOSE OR DISCONNECTED CONDUIT OR WIRING

There are a number of issues where the electrical conduit is poorly supported or damaged. Recommend qualified electrician review visible electrical conduit and connections and secure to walls and roof to prevent further damage.

Broken Connection

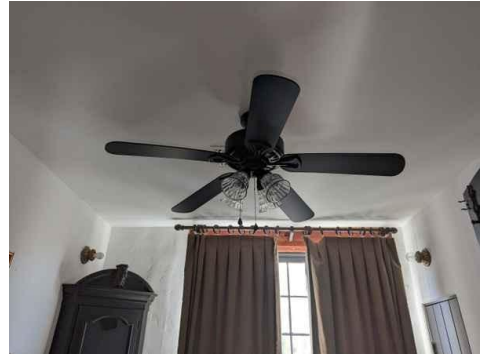
The ceiling light and fan in the library do not function. Recommend evaluation by electrical contractor.

### Recommendation

Contact a qualified electrical contractor.

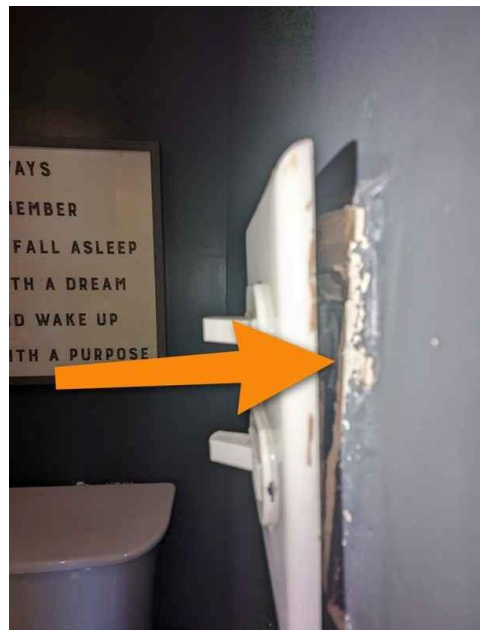
One outlet is not installed correctly in the guest house bathroom. Wall plates should be flush mounted. Recommend repairing to improve appearance.

### Recommendation

Contact a qualified electrical contractor.

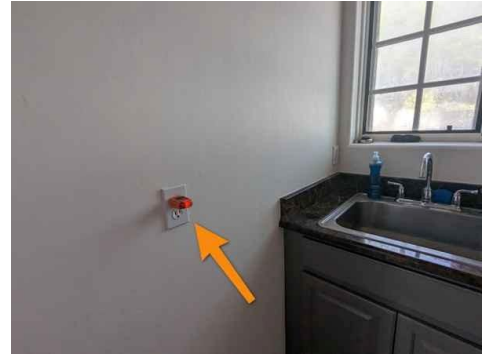
### 5.5.5 Lighting Fixtures, Switches & Receptacles

## UNGROUNDED RECEPTACLE

One receptacle is ungrounded in the guest house kitchen. To eliminate safety hazards I recommend this be rewired

Recommendation

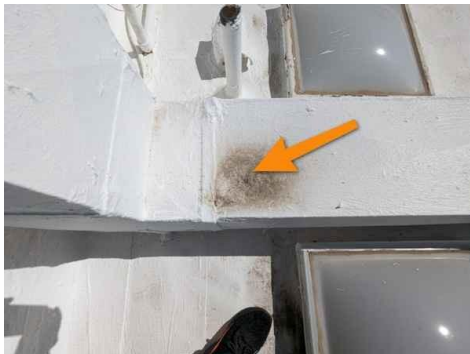
**DUCT SEALANT DETERIORATED**

Deteriorated sealant on roof mounted ducts has some areas that have deteriorated.  
Recommend roofer evaluate.

Recommendation

Contact a qualified roofing professional.

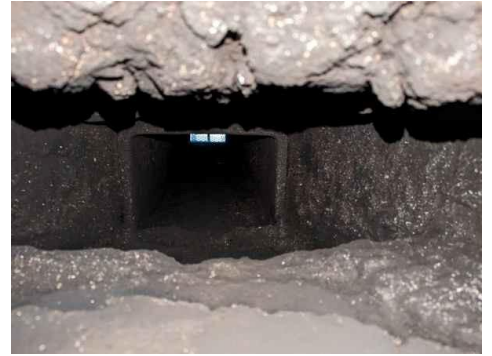
12.1.2 Vents, Flues & Chimneys

#### CHIMNEY LINER DIRTY

Recommendation

Contact a qualified chimney sweep.

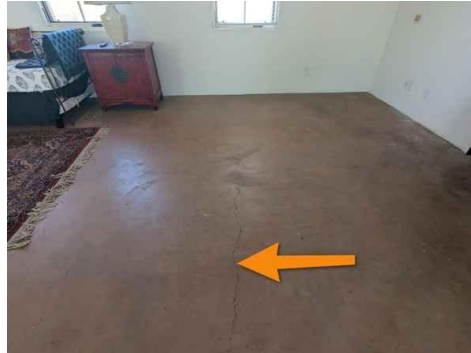
## 13.3.1 Floors

**Recommendation****CRACKED FLOORING**

There are minor cracks in concrete floor of the guest house. Recommend monitoring
